Case Report: Complex Tear of the Anterosuperior Labrum

Michael Recht, M. D

New York University Langone Medical Center, New York, USA

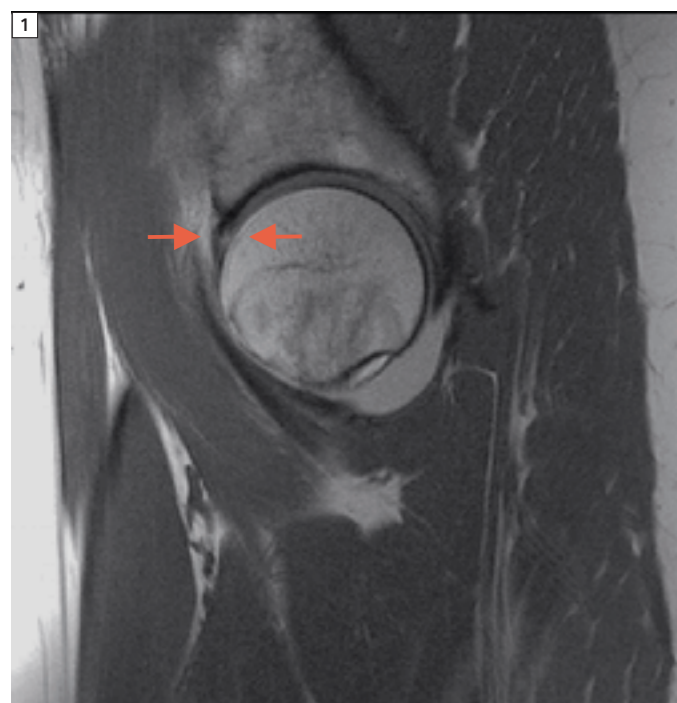
1 Sagittal T1-weighted image post intraarticular gadolinium injection on a 1.5T non Tim MAGNETOM Symphony. There is signal abnormality in the anterosuperior labrum suggestive of a labral tear. No gross defects are visualized in the adjacent articular cartilage but there is suboptimal delineation of the articular cartilage on the image.

arthrography of the left hip on a 1.5 T scanner. There were findings suggestive of labral tear (Figs. 1 and 2) but the pathology was not optimally visualized. In addition it was difficult to be certain

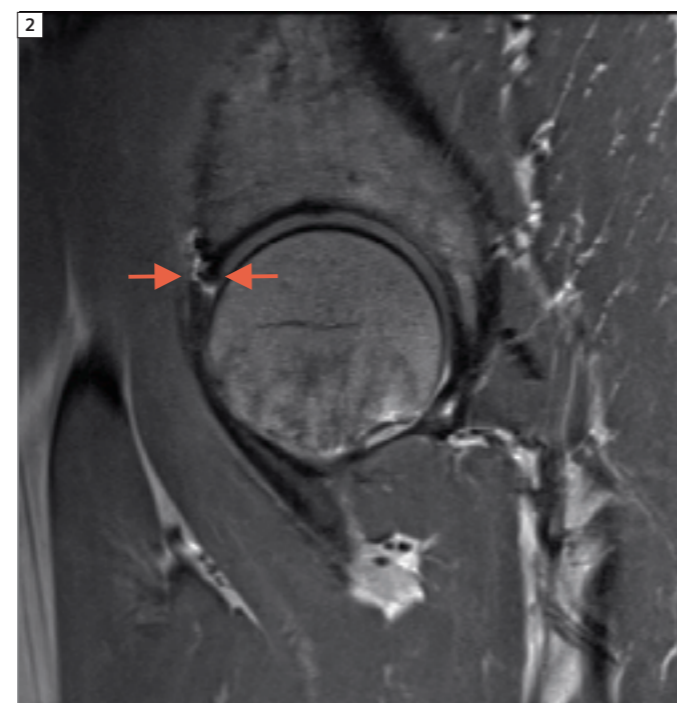
2 Corresponding sagittal Proton density MRI demonstrating abnormal signal in the labrum extending to the surface of the labrum consistent with a labral tear.

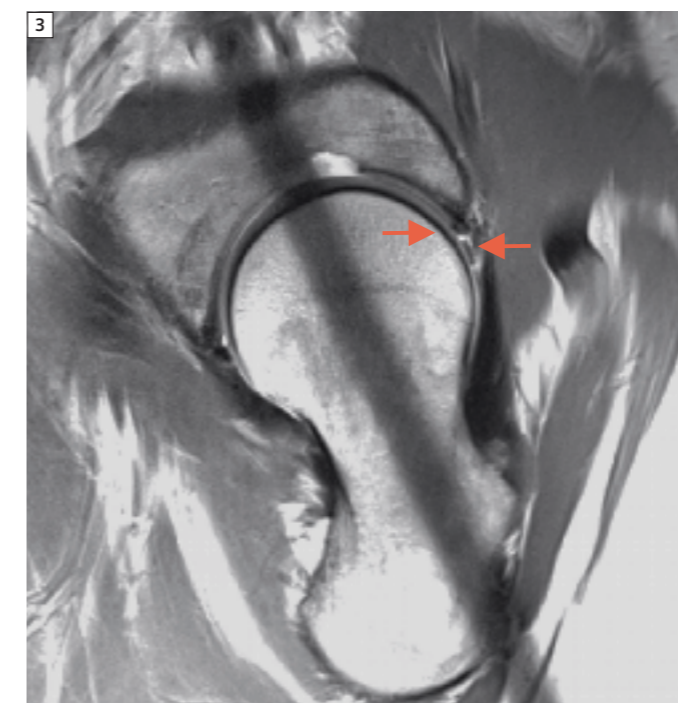
3 Radial Proton Density MRI at 3T demonstrating a complex labral tear with both a radial and longitudinal component. The adjacent articular cartilage appears normal.

There is a complex tear of the anterosuperior labrum best visualized on the radial images. There are both radial and longitudinal components of the tear. The additional dGEMRIC images (not shown) confirmed that the articular cartilage is within normal limits in this case.

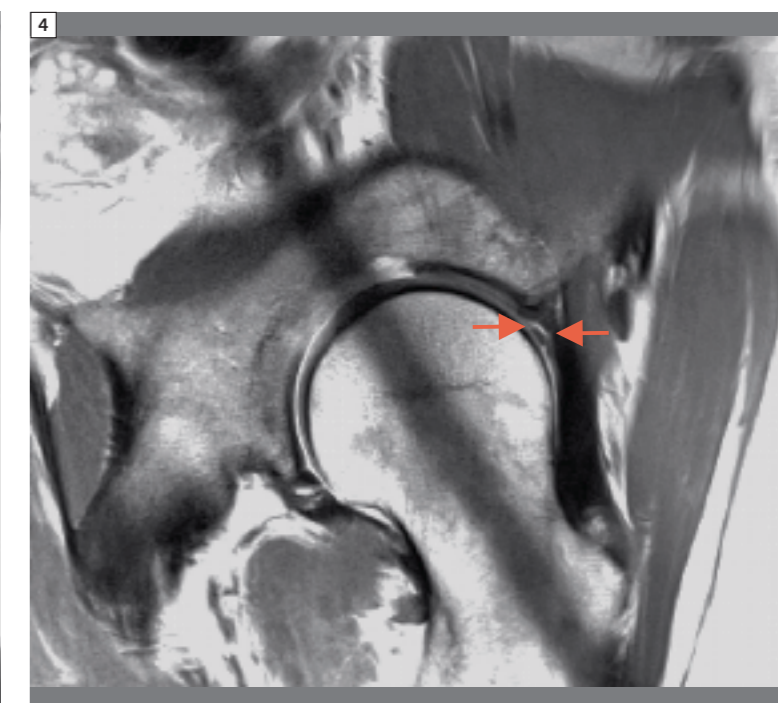
4 The longitudinal component of the tear is well visualized on this radial image (3T MR scan).
