Case 13

Screw Placement and Pelvic Osteoplastie Under CT – Fluoroscopic Guidance

By Ralf-Thorsten Hoffmann, MD*, Bianca Beyer, MD**, Tobias F. Jakobs*, Maximilian F. Reiser, MD*

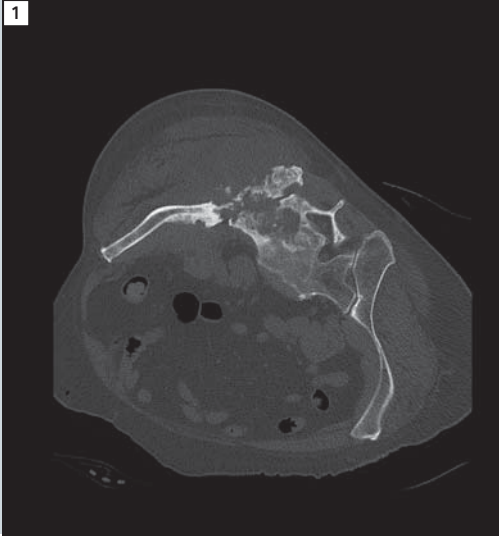
1 The CT examination showed a large osteolysis in the sacrum and the adjacent iliac bone.

The examination showed a large osteolysis in the sacrum and the adjacent iliac bone (Fig. 1). Furthermore, a pathological fracture was detected as stigmata of the recurring tumor.

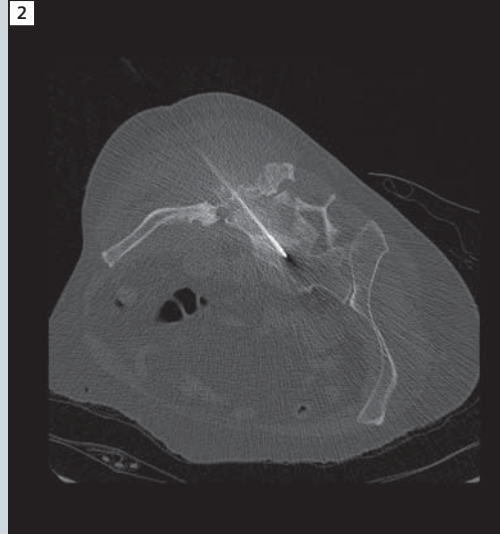
2 K-wires were positioned under CT fluoroscopic guidance using the i-Fluoro mode.

ance using the i-Fluoro mode (Fig. 2). The screws were placed via K-wires by the surgeon in order to avoid a too deep insertion of the screw head into the weakened bone (Figs. 3A-B). A major support for these control scans is the One Click Table Position, bringing the patient back to the exact same position, avoiding additional fluoroscopic CT examination. Procedure times and radiation exposures are thereby significantly reduced. After the insertion of two screws, (Fig. 4) the next step was the insertion and positioning of two vertebroplasty canulas into the osteolysis and application of the PMMA cement under CT fluoroscopic guidance by the radiologist using the needle artefact reduction tool i-Needle Sharp (Figs. 5A-B).

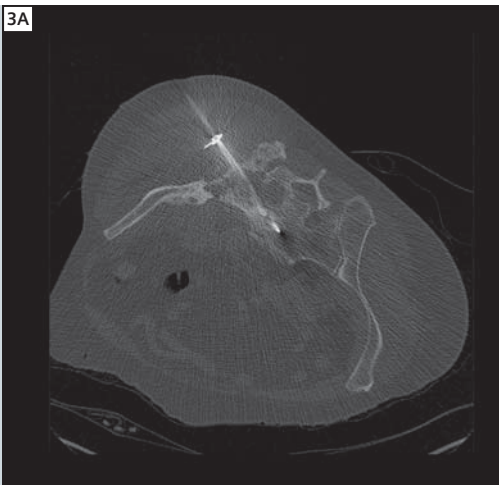
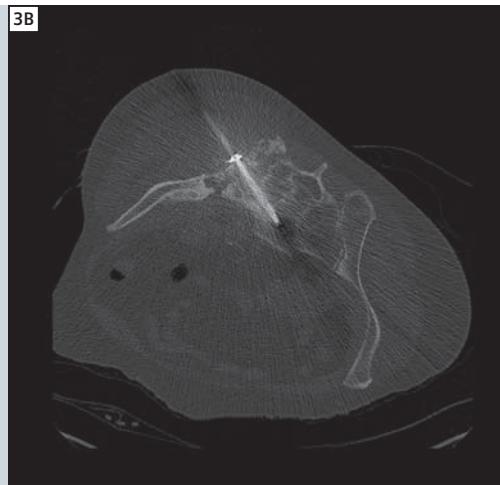
3 The screws were placed via K-wires in order to avoid a too deep insertion of the screw head into the weakened bone.

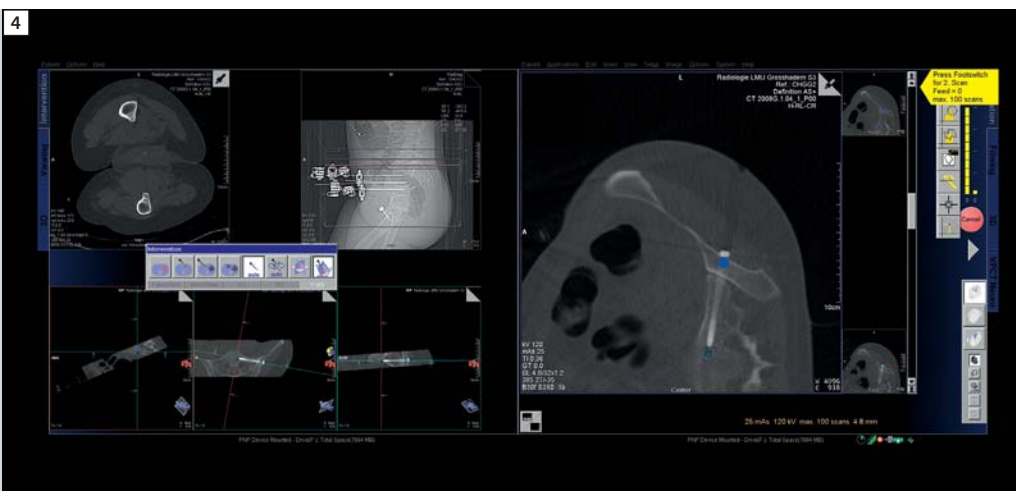
4 Two screws were inserted into the broken pelvic bone.

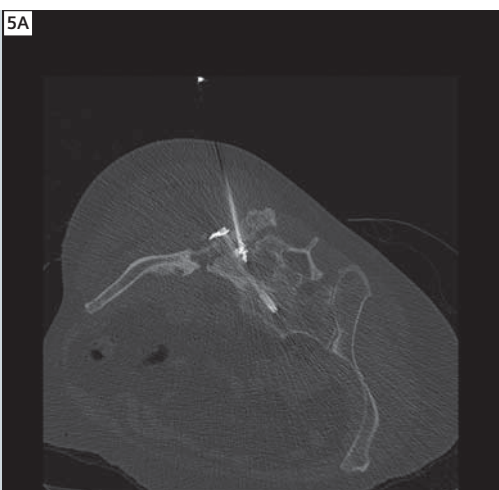
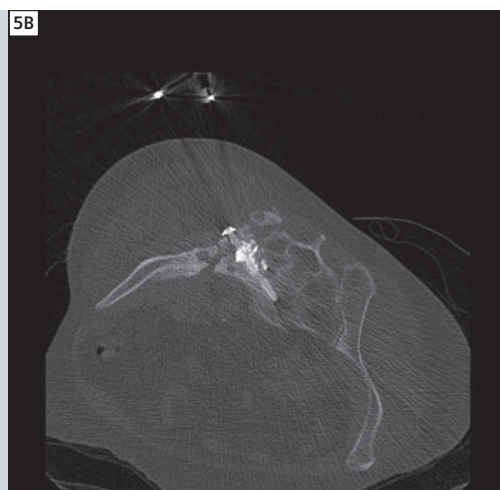
5 Two vertebroplasty canulas were inserted and positioned into the osteolysis (Fig. 5A) and PMMA cement was supplied under CT fluoroscopic guidance using i-Needle Sharp (Fig. 5B).
