Arthrography – A Realtime Evaluation of the Rotator Cuff

Courtesy of Jo Vandersmissen, MD
Department of Medical Imaging,
Ziekenhuis Oost-Limburg (ZOL), Genk, Belgium

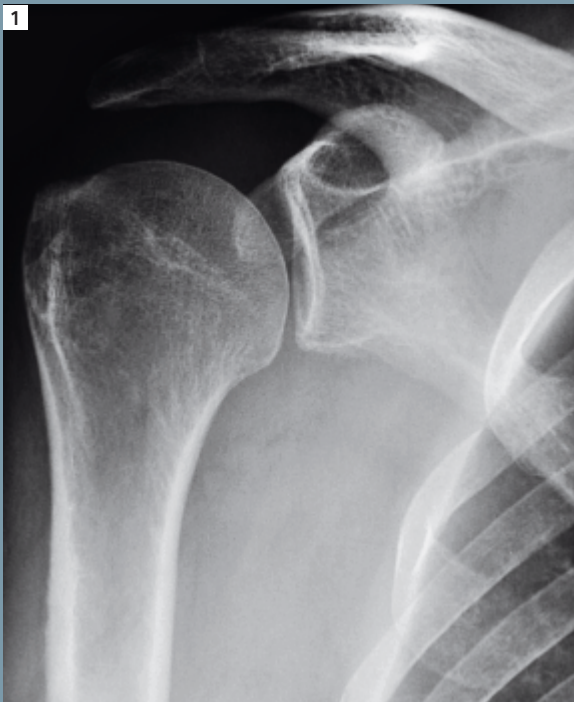
- 1 A.p. radiography of the right shoulder.
- 2 Contrast extravasation into the bursa subacromialis-subdeltoida reveals a complete rotator cuff tear.

Radiography: Standard radiography of the shoulder showed a normal bone pattern, slight degenerative changes of the acromioclavicular joint and a preserved space between the acromion and the humeral head. No calcifications could be seen in the soft tissues of the shoulder.
